Manhole Inspection Summary

Manhole # S3500_033MH

Insp Date: 1/30/07 1:31 PM

Location Address: **2410 CALVERT ST**

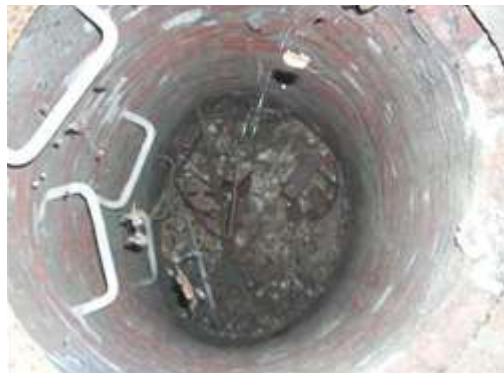
Top View

Corbel and Barrel infiltration. Channel debris.

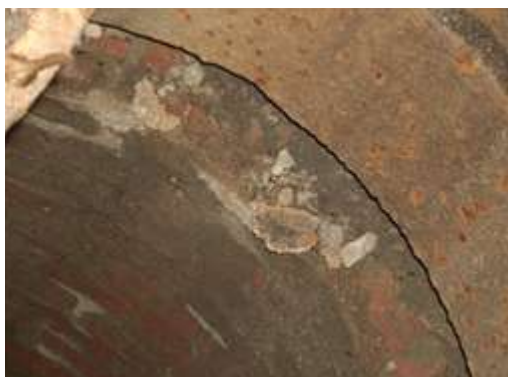
Defect

Frame leaks. Frame offset. Adjustment deterioration and infiltration.

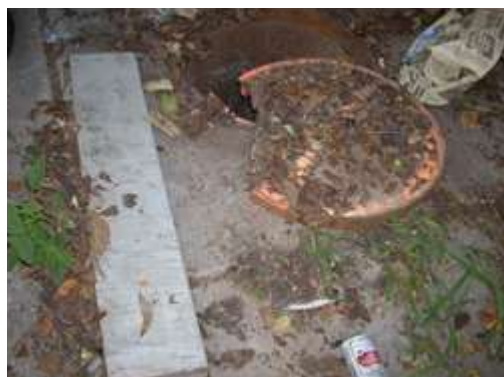
Defect

Broken cover.

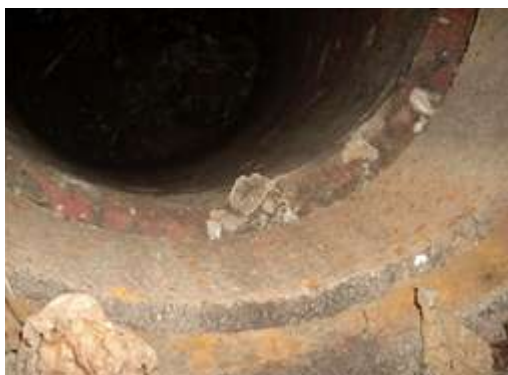
Defect

Frame leaks. Frame offset. Adjustment deterioration and infiltration.

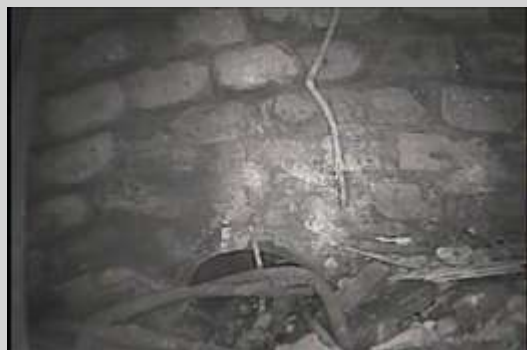
Pipe Out @ 12 O'Clock

Deposits: ☐ None ☒ **Mud** ☐ Sludge ☒ **Debris** ☐ Grease

Silt Depth: **4** (in.)

Deposits Extent: **Medium**
